Rhode Island College 2010-2020 Master Plan

Final Report

November 2010

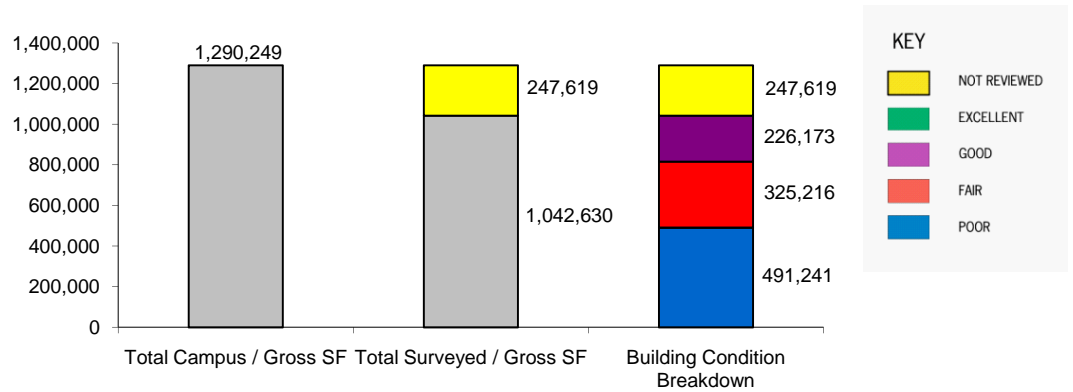
Figure 1.4
Building Conditions Survey

Approximately 1,042,630 sf of campus buildings was surveyed. Figure 1.4 illustrates the square footage by condition category.

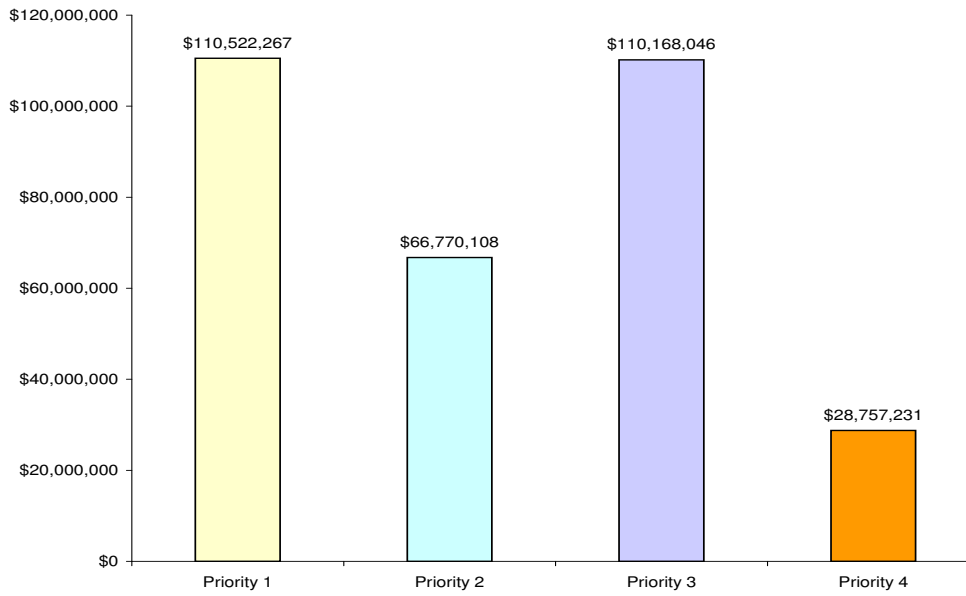
Figure 1.5
Building Renovations by Priority Level

- Architectural category contains square foot cost for renovation (includes all other systems)
- Total estimated cost for all priority levels = \$316,217,652

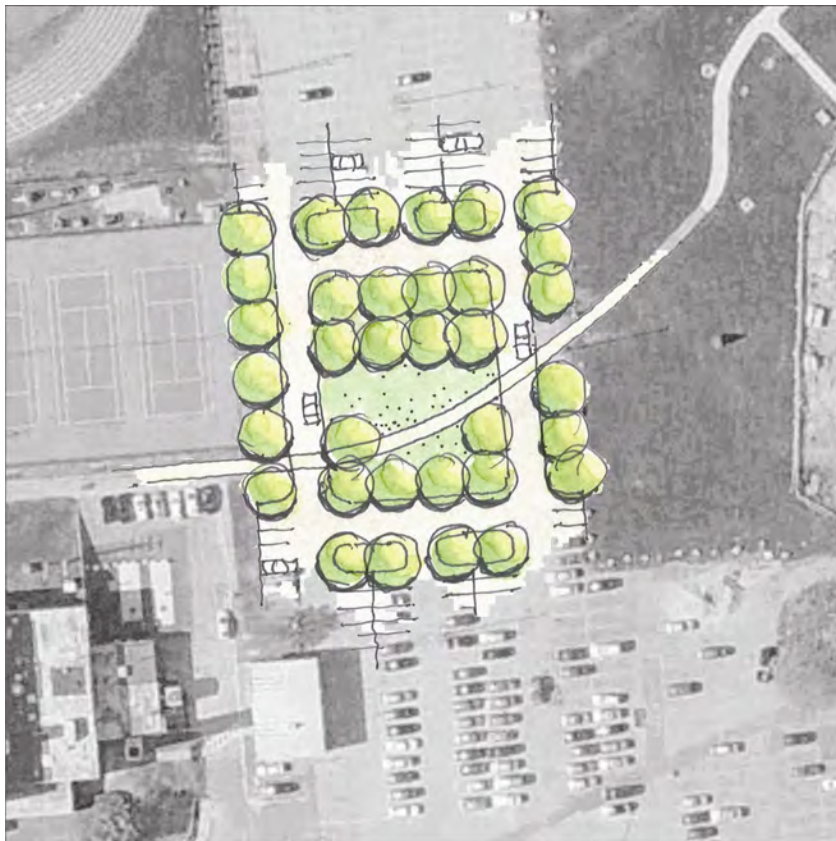
Existing Parking Lot "B" conditions

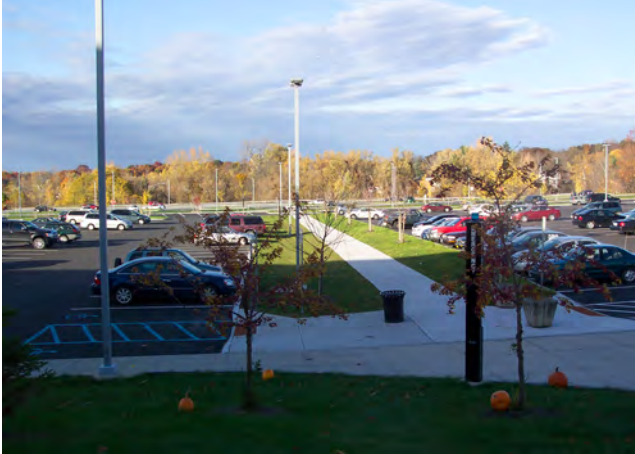
Concept to connect main capus to east capus through Parking Lot "B"

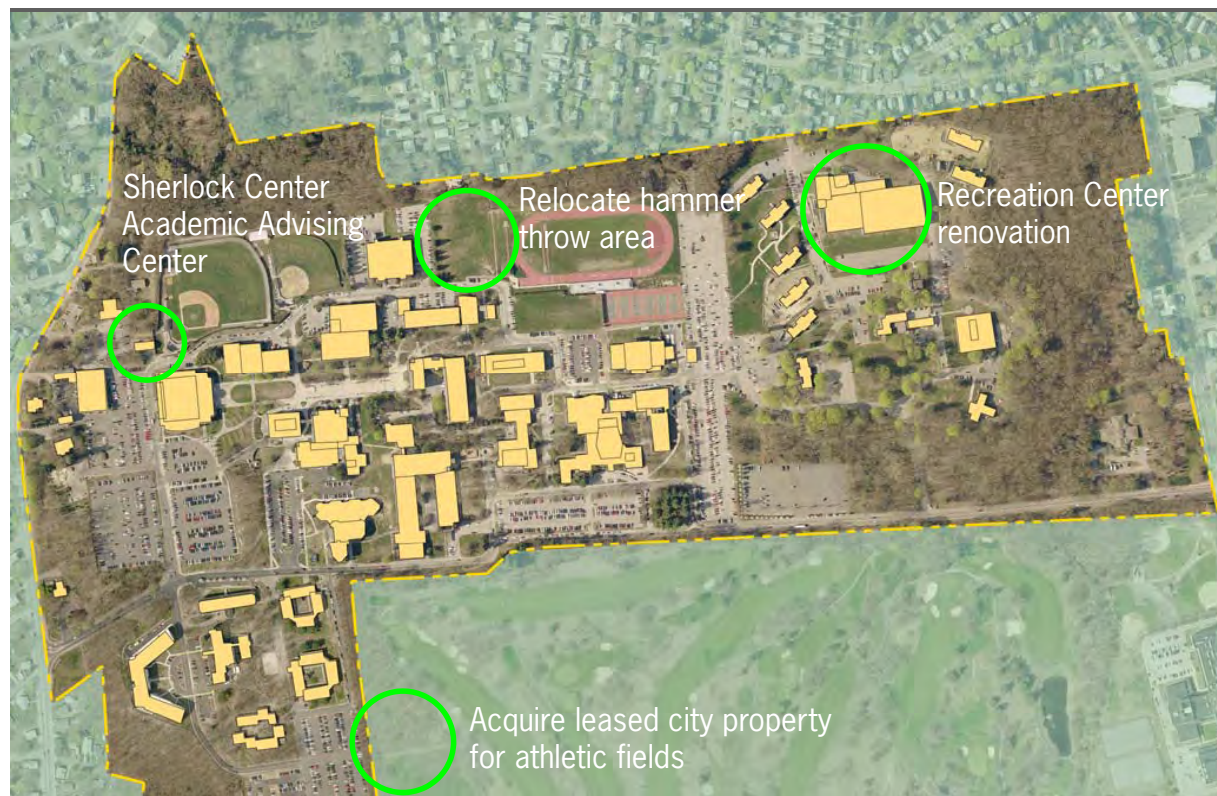
ATHLETICS & RECREATION PLAN

The existing outdoor areas dedicated for athletics are well defined along the northern edge of the campus. These involve fields for baseball, softball, track and field, soccer, lacrosse, and tennis courts to support NCAA Division III athletics. The hammer throw area located between Fogarty Life Science Building and the track is a prime site for an infill building to expand the academic precinct of the central campus. Development of this site would require the relocation of this field event.

The area currently leased on the adjoining golf course is used as a practice field. Acquisition of this property provides the opportunity for expanded athletic and recreational use. The proximity of this area to the student housing precinct creates a desirable adjacency for informal and intramural student recreation. It is recommended that RIC acquire this property.

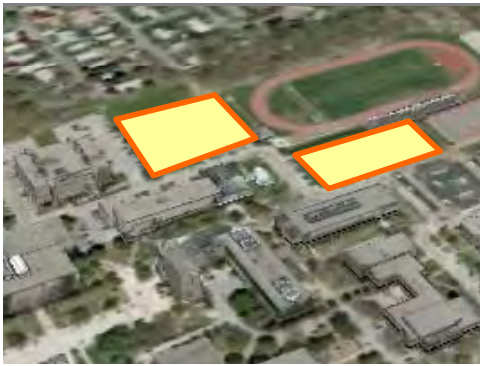
- Building zones were identified for portions of Parking Lots “A” and “J.” Lot “J” provides an excellent opportunity to develop a parking structure that could also incorporate mixed-use elements such as athletic facilities on the roof-top and academic/support spaces as part of the structure. The effect of displacing parking from the development of these sites would need analysis to determine parking needs prior to adding new parking.

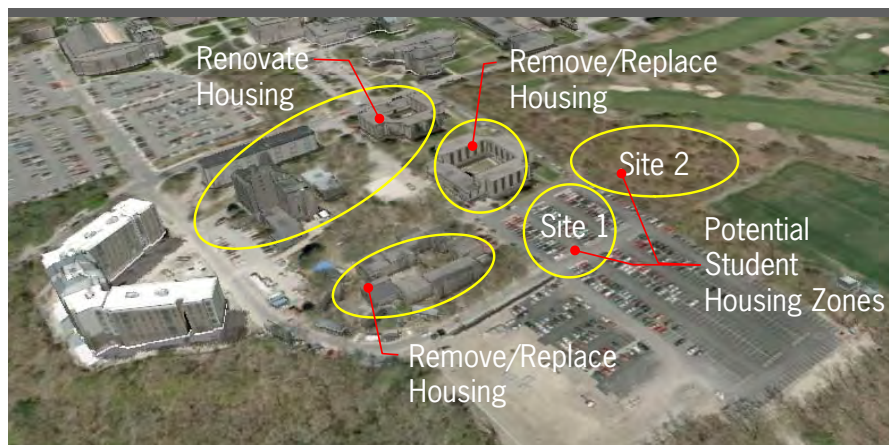
- | | |

The strategy to achieve the bed count for the short-, mid-, and long-term requires a plan that does not reduce the current bed count as new student housing is being implemented. In order to achieve this, two undeveloped building zones were identified. Site one is located to the south of Weber Hall on a surface parking lot. Site two is located on a leased portion of the adjacent golf course to the southeast of Weber Hall. This option would require the purchase of property. The development of new student housing on either site would then allow for the removal of Willard Residence Hall followed by the removal of Weber. Once the residence halls in “poor” condition were retired, new student housing could be developed on these sites to fulfill the long-term goal of 1,750 beds.

- STUDENT HOUSING TO BE RENOVATED
- STUDENT HOUSING IN "POOR" CONDITION TO BE REPLACED WITH NEW BEDS
- POTENTIAL ZONE FOR STUDENT HOUSING
- POTENTIAL PROPERTY ACQUISITION FOR ATHLETICS, RECREATION AND/OR STUDENT HOUSING

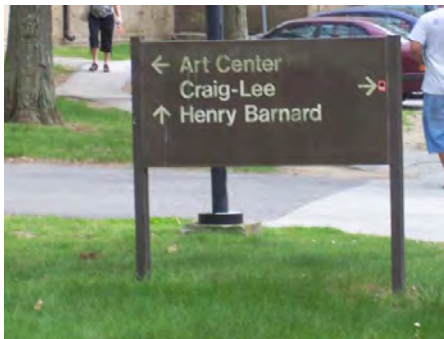
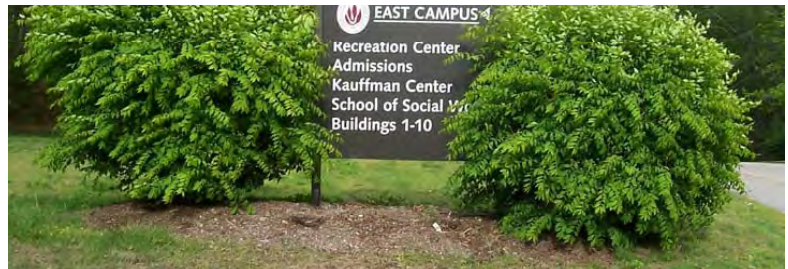
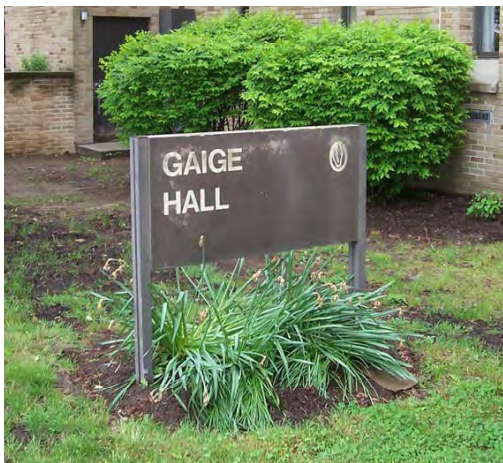
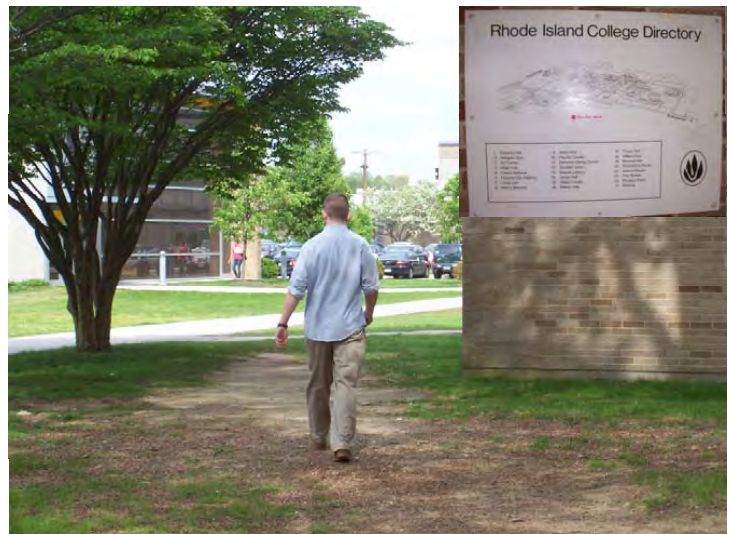
Existing RIC Signage

Examples of existing campus signage in poor condition are illustrated below along with signage on other campuses that have been designed as a graphic system that reflects the individual college.

18. Refuse and recycling containers – select new container that is compatible with existing site furniture
19. Campus signage – develop new signage system for the campus; i.e. traffic and regulatory, building identification, wayfinding and identity signage. (See examples of existing campus signage that is dated and in poor condition)

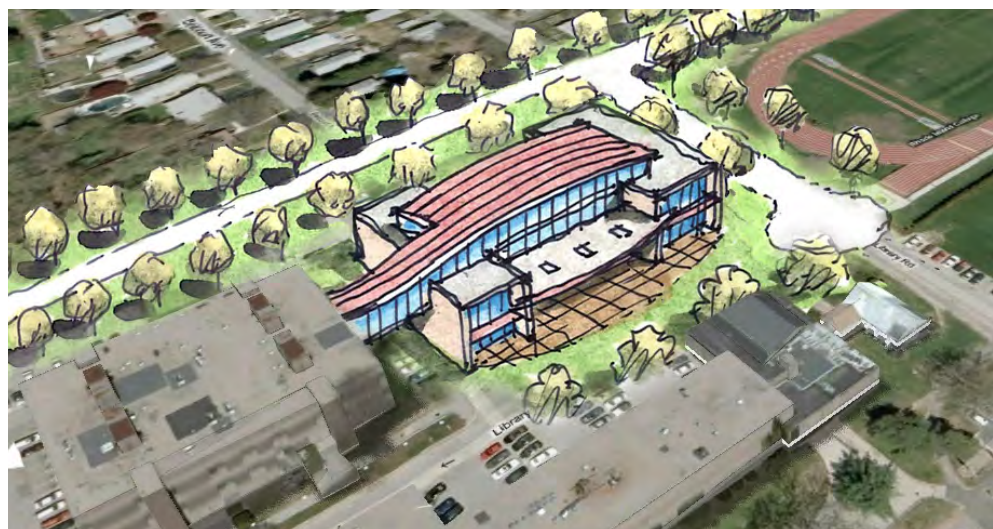
OPTION 2

This option locates the proposed space program for nursing in a free standing building to the north of Alger Hall. Proximity to the Life Sciences is less than Option 1, but still within the academic zone of the campus.

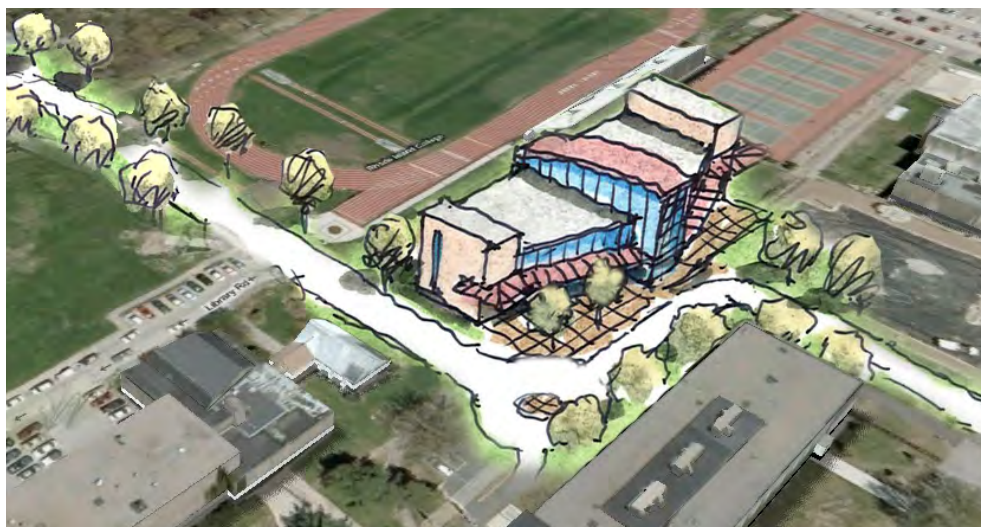
OPTION 3

Option 3 considers the development of a new building for nursing to the east of Whipple Hall with the potential to renovate Building 2 for nursing. If Building 2 was used for some of the Nursing Program, the 53,500 GSF would be reduced accordingly. This site provides the opportunity to link the east and central campus areas. It would require significant site work related to roadway, parking, open space, and pedestrian circulation enhancements.
